WORDING FOR AGENDA ITEM: Courthouse- South East Windows Needing Emergency Repair

RE: Woodbury County Courthouse Courtroom Windows, Emergency Action

WINDOW STUDY

SOUTHEAST COURTROOM 203
WOODBURY COUNTY COURTHOUSE / SIOUX CITY, IOWA

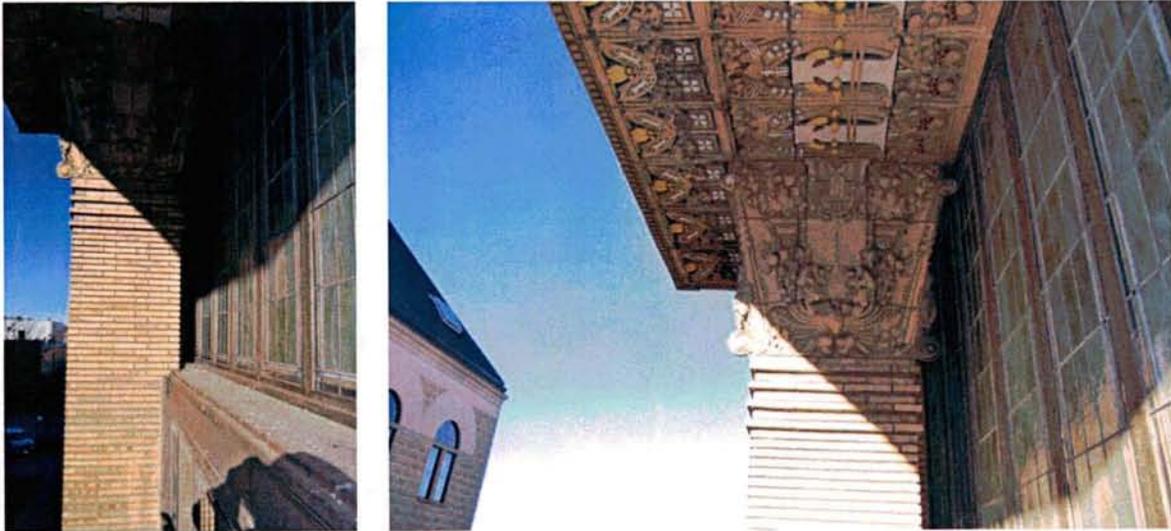
Condition: The photos below indicate the general condition of the Steel Sash containing the Art Glass at the Window Assembly. The portion of the paint system, exposed to the exterior, protecting the steel material, has generally deteriorated, exposing the steel, which exhibits surface rust. Sealants are missing, hardened or cracked in various locations.

Art Glass Windows – looking West

Recommendation: that the remnants of the exterior paint system be removed; the surface rust be removed or otherwise neutralized; a new paint system be installed. Provide an entirely new sealant system.

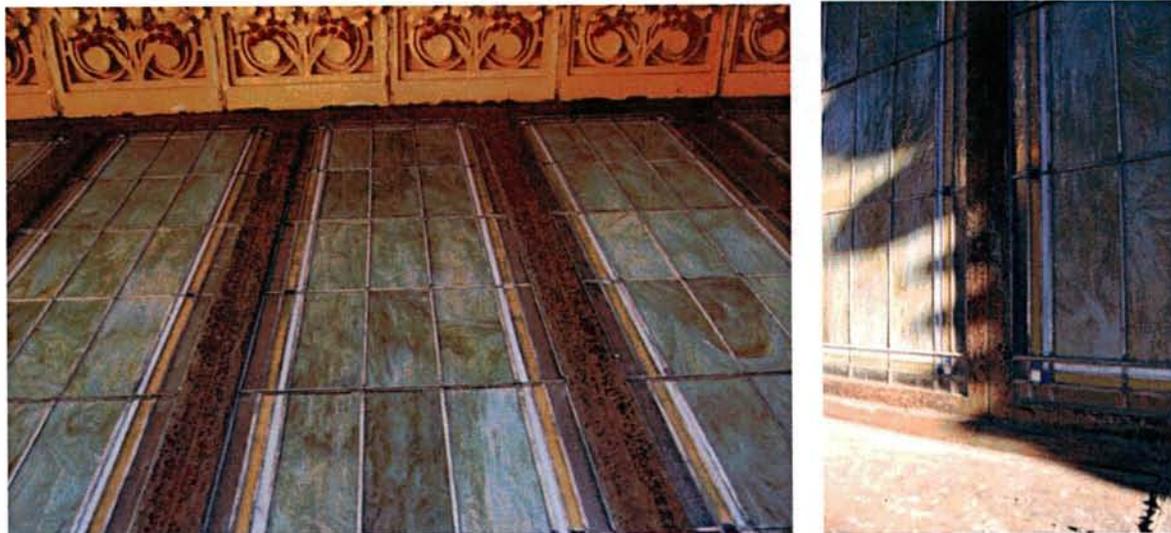
Steel Sash at Art Glass Windows – Views of Deteriorated Paint System & Surface Rust

During this procedure, the steel sash pieces shall be closely examined for deterioration, beyond 'surface' rust condition, and appropriate repairs be made at that time. It is not expected that removal of the existing steel sash will be required.

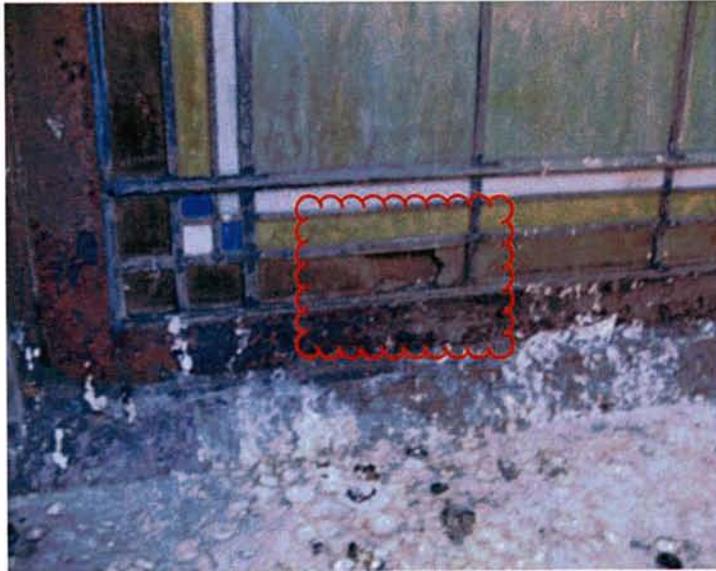
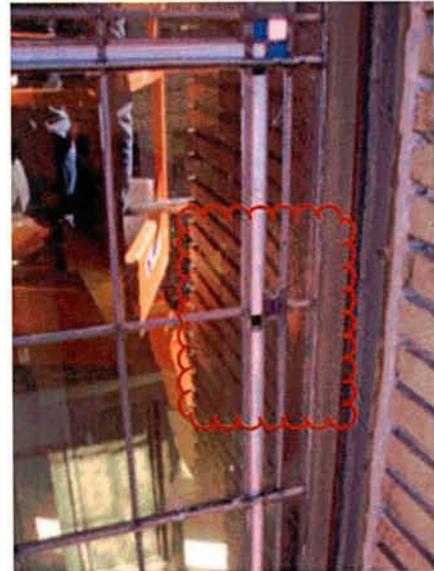
For information purposes, the photos below show two (2) areas where glass is broken or missing and one (1) area where the glass has shifted and deformed:

Missing Pieces of Art Glass, (shown within 'clouds')

Condition: information given during on-Site interviews is that a company that specializes in stained glass repair & construction will be consulted for required repairs, where necessary. As such, no recommendations are offered.

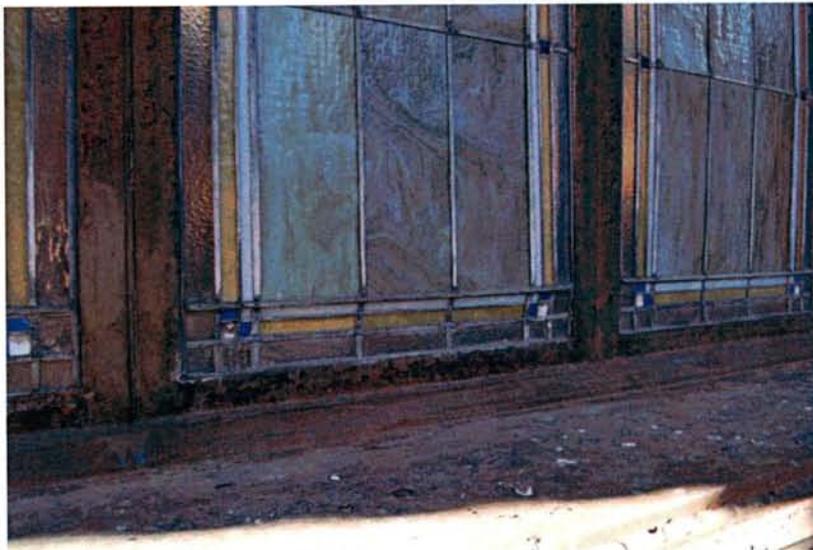
Deformed Area at Bottom of Art Glass Panel

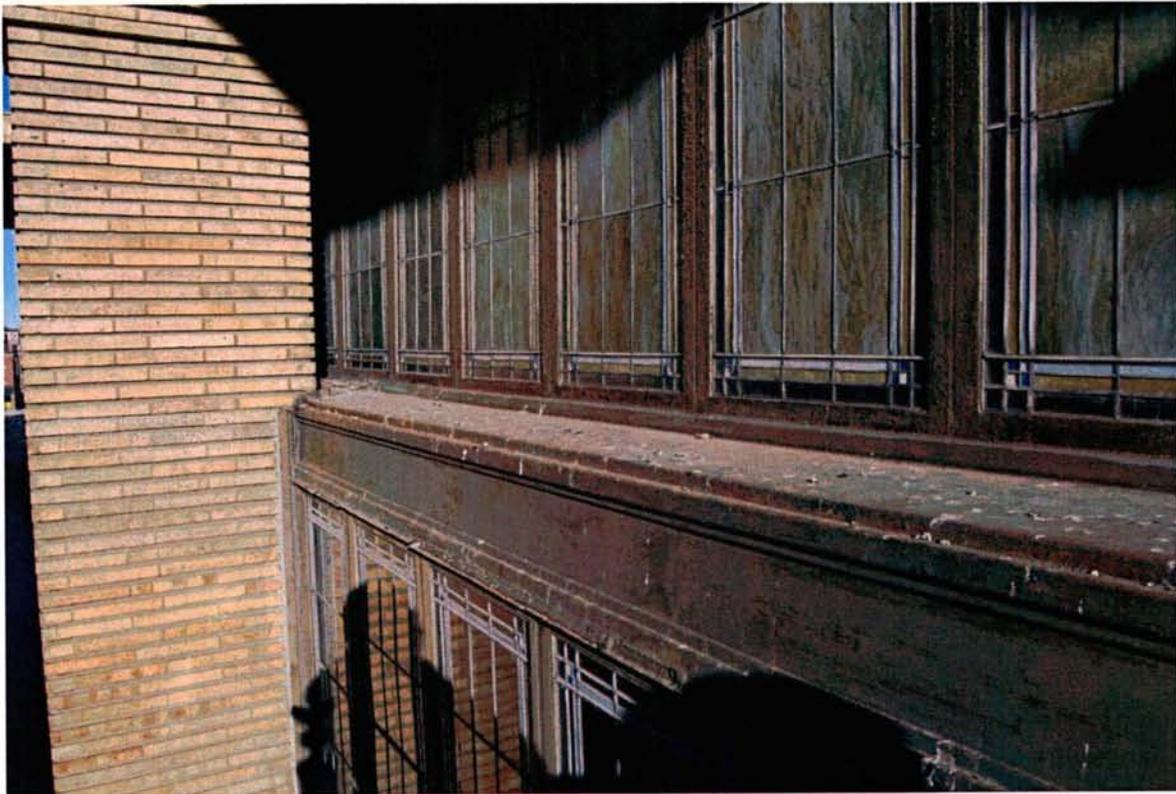
General Condition: The photos below indicate the general condition of the Steel Transom. The paint system, protecting the steel material, has generally deteriorated, exposing the steel, which exhibits surface rust. The top surface of the Transom is covered with grime and bird droppings. Sealants are missing, hardened or cracked in various locations. There are various maintenance repairs that have been made over time that require attention.

*View along top of Steel Transom – Looking West
(Note bird droppings and various areas of surface rust)*

Recommendation: that the existing paint system be removed, along with the grime and bird droppings; the surface rust be removed or otherwise neutralized; a new paint system be installed. Provide an entirely new sealant system.

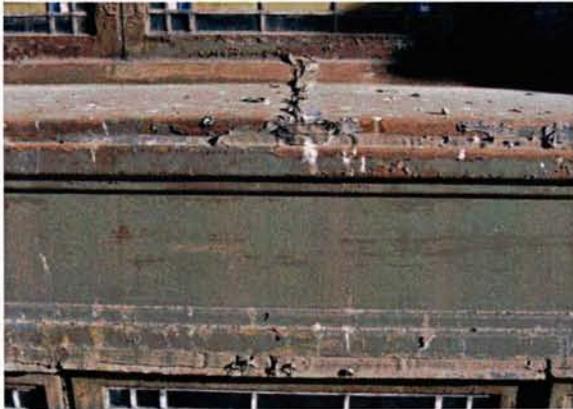
Exterior View - top of Steel Transom – Caulked Splice Cover

Interior View - top of Steel Transom – Steel Slip

(Note that one such joint exists, located at the center of the steel transom, and that prior to re-caulking this joint in the Fall of 2015, light could be viewed from the interior & rain leaked at this area.)

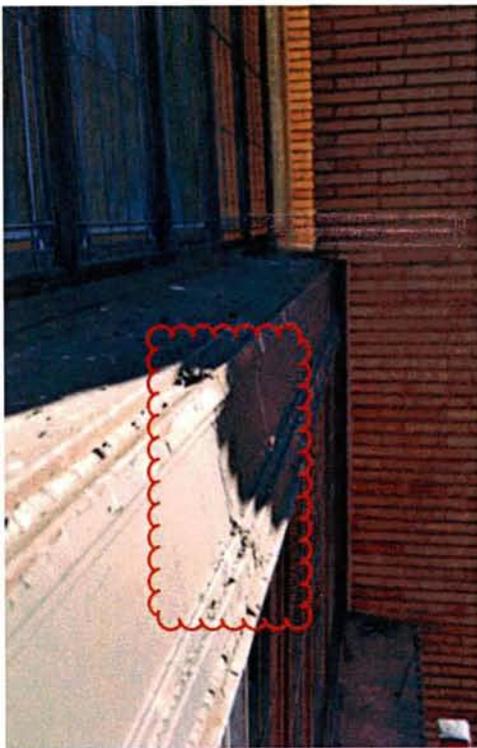
Exterior View at face of Steel Transom – Caulked Splice

Interior View at face of Steel Transom – Steel Slip Cover

(Note that one such joint exists, located four feet east of the center of the steel transom, and that prior to re-caulking this joint in the Fall of 2015, light could be viewed from the interior & rain leaked at this area.)

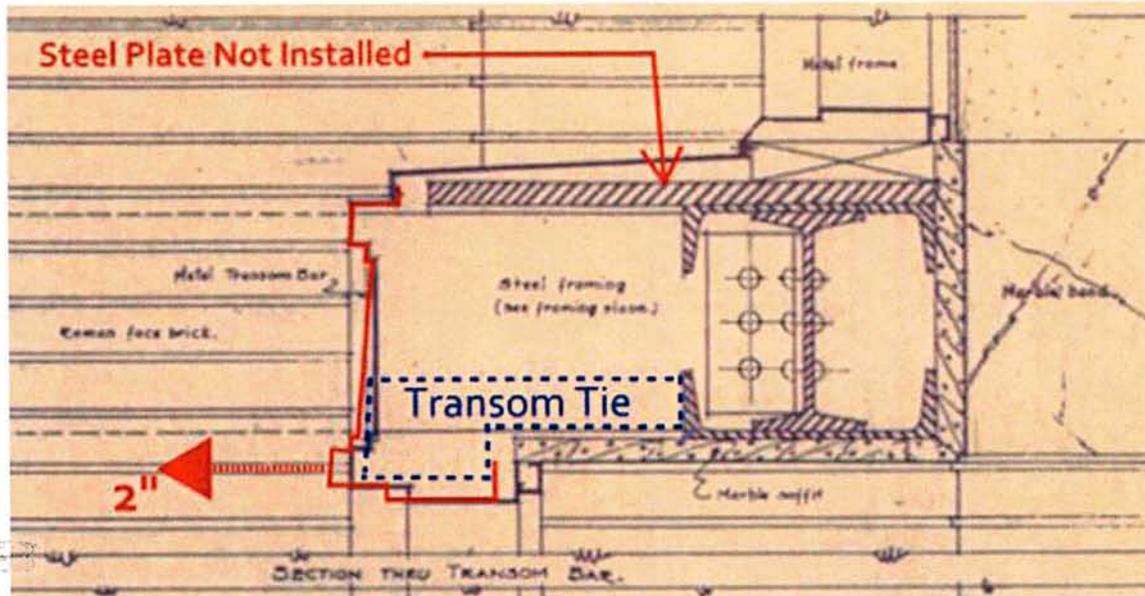
Condition at Bowed Shape: the position of the east and west ends of the steel transom, (in relation to the masonry piers at either side of the central portion of the window assembly), seems to be the same as when constructed in 1916-18; however, the center of the steel transom has bowed out, away from the interior of the building, by 2 inches, (see diagram, below).

This movement has caused a gap between the steel transom metal, (which has moved), and the marble soffit material, (which has not moved).

As the movement is most severe at the window (southeast) that has received the most sun over the years, it is conjectured that the beam & transom elongate with the heat and bow outward. When conditions cool, the beam straightens out, but the transom, which is tied to the windows below, stops slightly short of straight. During the 100 years life of the building, this slightly less than straight recovery has permanently warped the shape of the transom.

Recommendations: rather than dis-assemble the entire window assembly and replace the transom material with new, straight material, our opinion is that tying the vertical face of the transom in place, to contain the transom and prevent additional bowing, seems the logical alternative.

Adding a horizontal tie within the transom, between the exterior face of the structural steel and the inner edge of the transom, just above the windows, (see diagram above), would allow the transom to move with heat buildup, but keep it in a parallel relationship to the structural steel, which would bring it back to its original position when conditions cooled. (Note: a structural engineer's opinion would be required for configuring this design.)

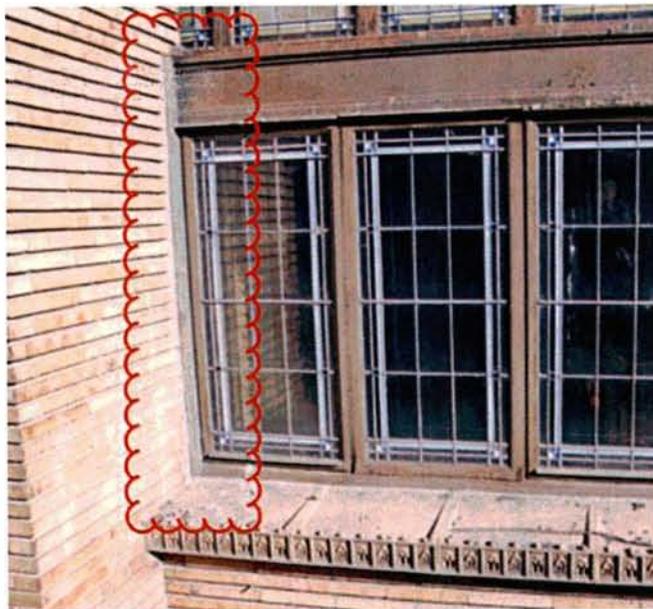
General Condition – 'Extra' Steel Channels: The photos below indicate vertical steel channels that have been installed at locations where the lower (clear glass) windows meet masonry walls; this occurs only at the Southeast Courtroom Windows. The vertical edges of the channels are caulked against the masonry and the window sash; the open, upper and lower ends of the channels have been filled with sealant; some of which is missing.

It is assumed that gaps between the masonry and window sash developed that were too wide to effectively receive (and hold) sealants; and that the channels were applied to cover the gaps.

Steel Channel at Lower Window Jamb & Steel Transom – West End of Center Windows

Recommendation: that the channels be removed and a less obvious means be developed to extend the metal window sash. Provide an entirely new sealant system.

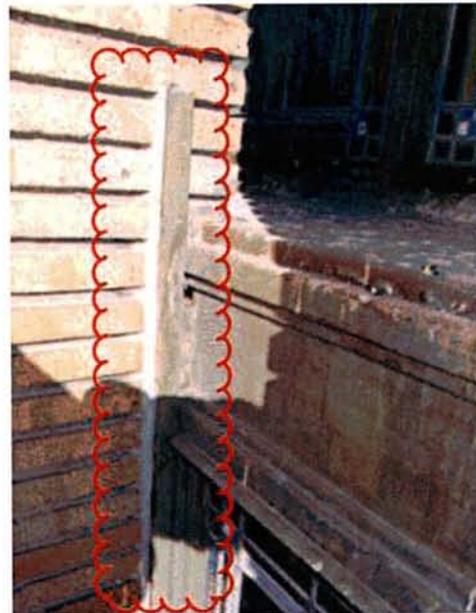
Steel Channel at Lower Window Jamb & Steel Transom - East Side of East Masonry Pier

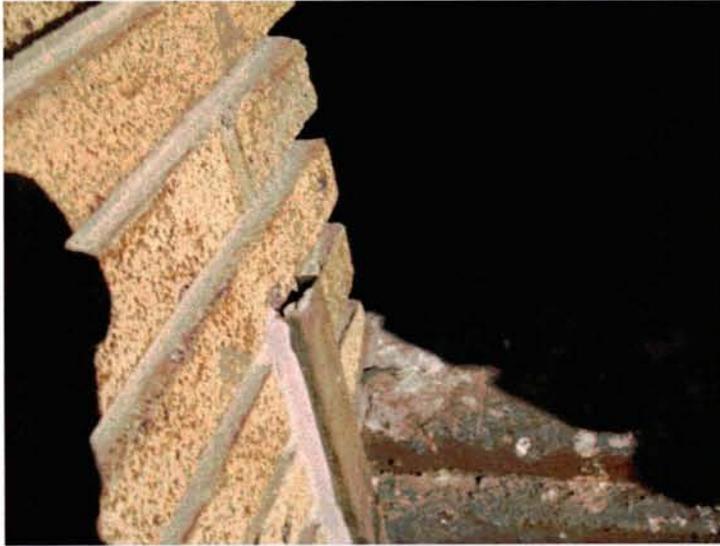
*Top of Steel Channel above Steel Transom –
East Side of East Masonry Pier – Sealant Missing*

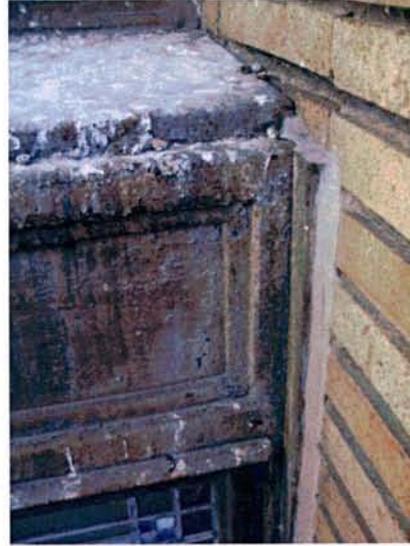
*Top of Steel Channel at Steel Transom
– East End of Lower Window
Assembly - Filled with Sealant*

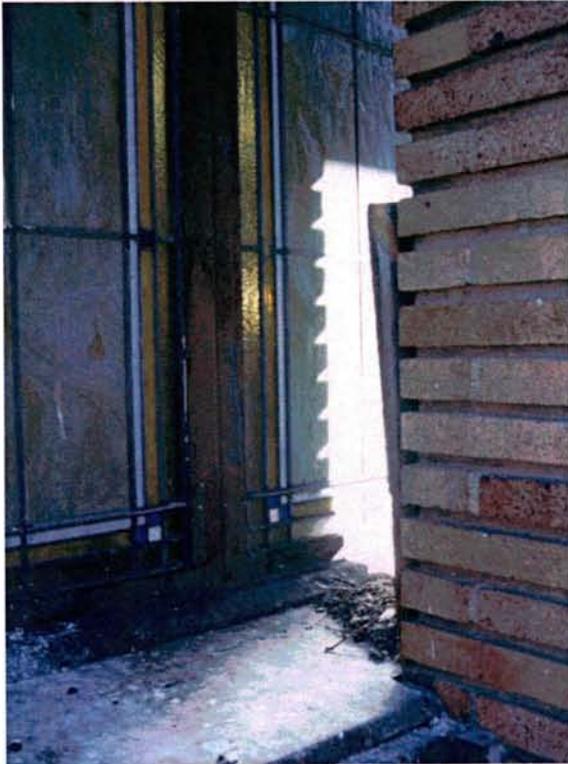
General Condition – Wood Fill Piece: The photos below indicate a gap that developed between the top of the Steel Transom and the north side of the West Masonry Pier; (this condition does not occur at the East Masonry Pier). It appears that the east end of the gap has been filled with sealant, but when the gap became too large to caulk, a wood board was inserted as a filler.

It is assumed that this area has allowed rain and cold to enter the building.

View from Southwest – Showing Wood Filler above Transom at North Side of West Masonry Pier

Recommendation: that the wood filler be removed and a bent sheet metal piece be installed to fill the gap. Shape the sheet metal filler to receive sealant; pop-rivet the filler to the transom. Provide an entirely new sealant system.

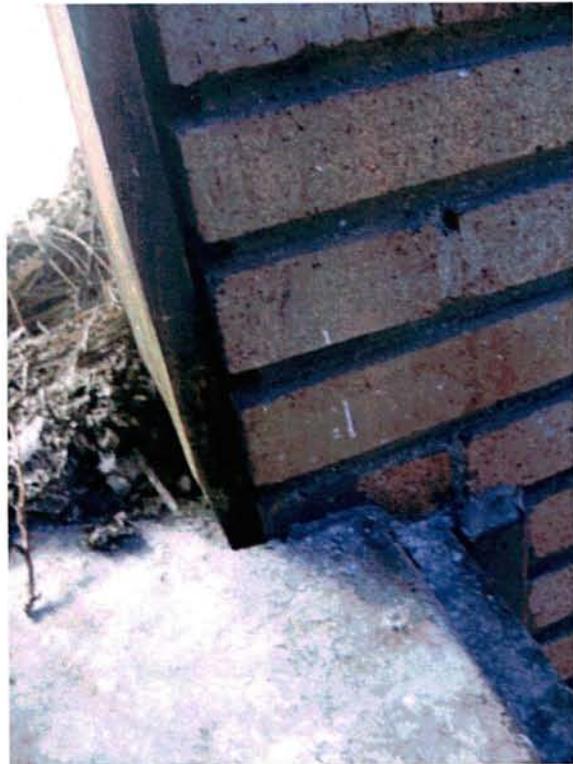
View from West – Showing Wood Filler and Gap Between Transom and North Face of West Masonry Pier

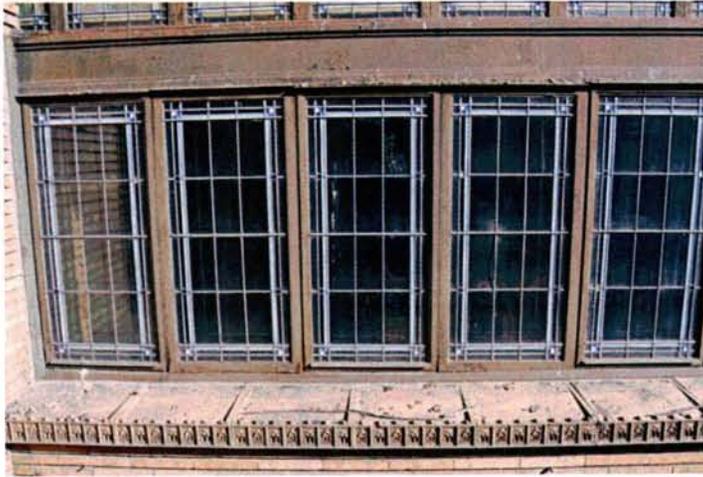
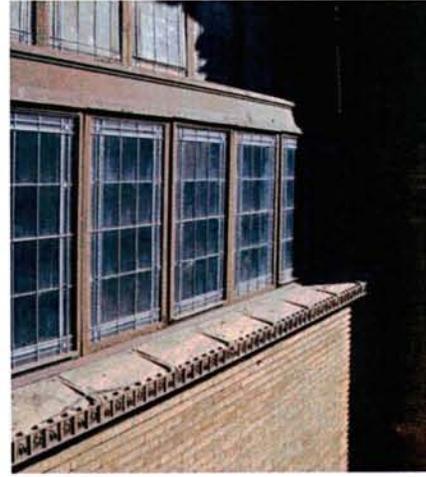
Condition: The photos below indicate the general condition of the Lower Steel Window Sash, (both 'Operating' and 'Fixed'), containing the Clear Glass at the Window Assembly. The portion of the paint system, exposed to the exterior, protecting the steel material, has generally deteriorated, exposing the steel, which exhibits surface rust. Portions of the steel sash at the 'fixed' windows are severely deteriorated. Sealants are missing, hardened or cracked in various locations.

View of West Portion of Center Windows

View of East Portion of Center Windows

Recommendation: that the remnants of the existing exterior paint system be removed; the surface rust be removed or otherwise neutralized; a new paint system be installed. Provide an entirely new sealant system.

During this procedure, all steel sash pieces shall be closely examined for deterioration, beyond 'surface' rust condition, and appropriate repairs be made at that time. It is not expected that removal of the existing steel sash will be required, except as noted in the paragraph below.

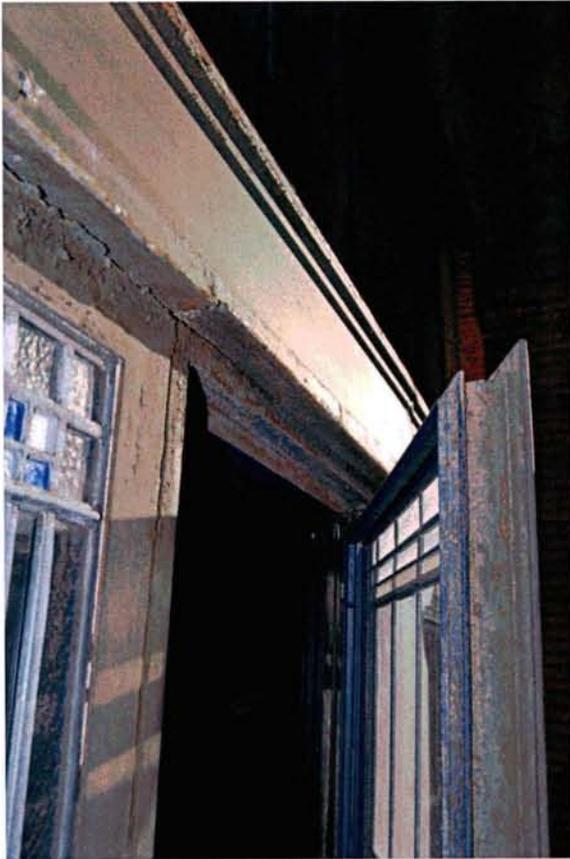
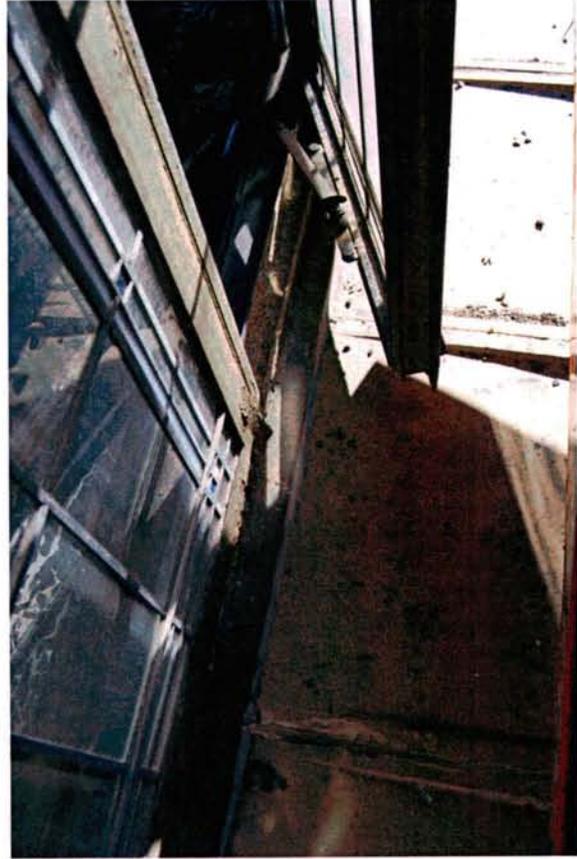
Condition: The portion of the paint system, exposed to the exterior, (including the interior portion of the operating sash, protecting the steel material, has generally deteriorated (exterior portion of window, exposing the steel, which exhibits surface rust), and is in a somewhat worn condition (interior portion of operating sash). Sealants are missing, hardened or cracked in various locations.

View of Upper Portion of Operating Sash

View of Lower Portion of Operating Sash

Recommendation – Exterior Surfaces: that the remnants of the existing exterior paint system be removed; the surface rust be removed or otherwise neutralized; a new paint system be installed. Provide an entirely new sealant system.

Recommendation – Interior Surface of Operating Sash: that the existing interior paint system, at the operating portion of the window, receive an additional coat of paint.

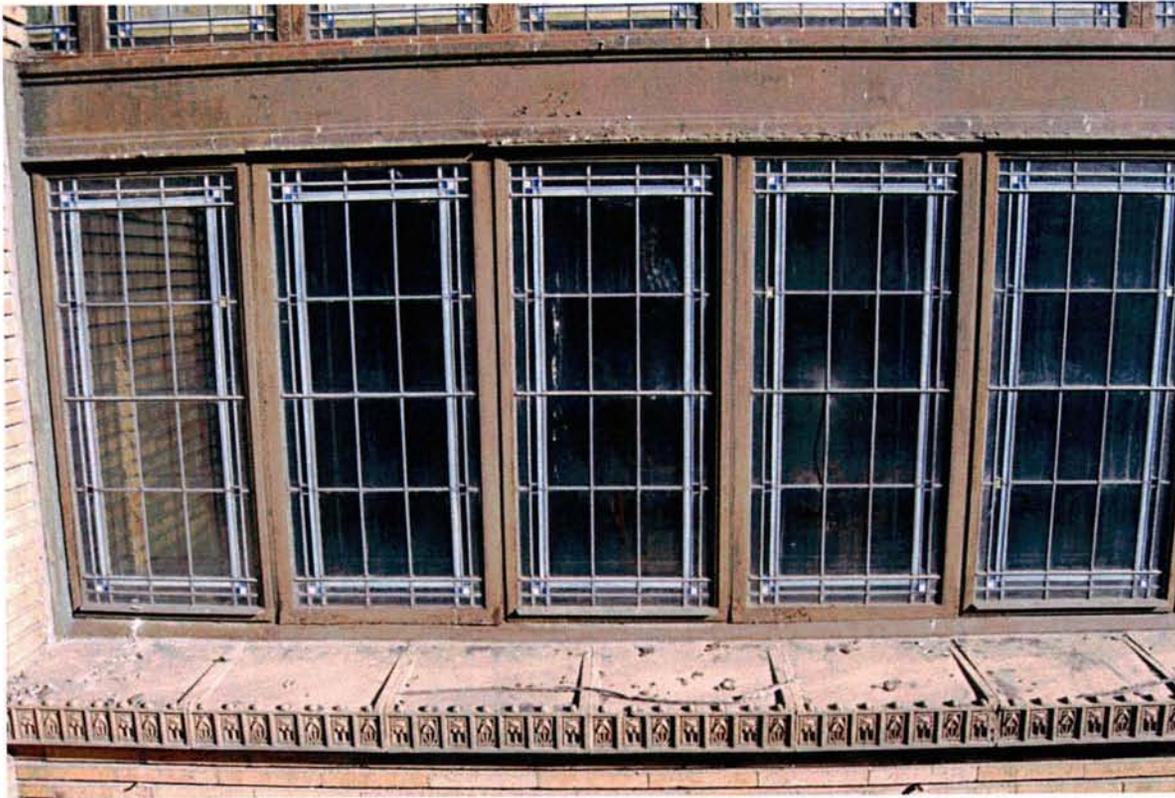
Condition: The portion of the paint system, exposed to the exterior, protecting the steel material, has generally deteriorated, exposing the steel, which exhibits surface rust at most locations. Sealants are missing, hardened or cracked in various locations.

In addition, at the lower corners of the some of the fixed windows, the steel is deteriorated to the extent that it is flaking in layers from long-term rusting.

View of Fixed & Operating Sash - Note the deteriorated portions of the Fixed Window Sills

Recommendation: that the remnants of the existing exterior paint system be removed; the surface rust be removed or otherwise neutralized; a new paint system be installed. Provide an entirely new sealant system.

During this procedure, all steel sash pieces shall be closely examined for deterioration, beyond 'surface' rust condition, and appropriate repairs be made at that time.

At the bottom portions (sills) of these windows, methods shall be investigated to make repairs 'in place', if at all possible; however, it is a possibility that removal of the existing steel sash will be required to affect repairs.

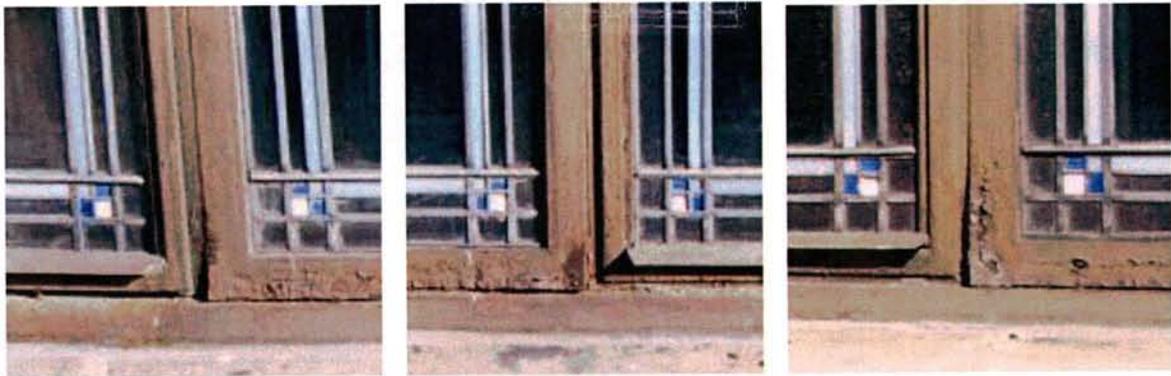
Closeup Views of Fixed & Operating Sash - Note the deteriorated portions of the Fixed Window Sills

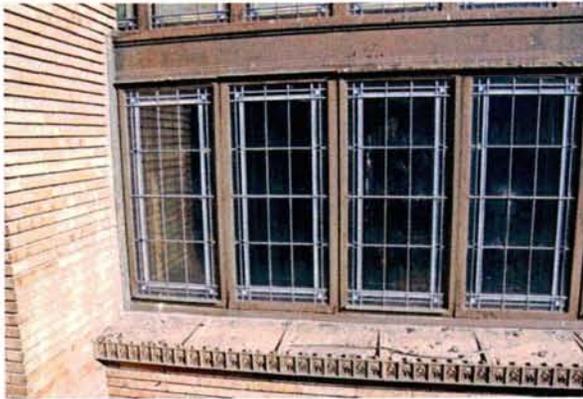
Condition: The photos below indicate the general condition of the Terra Cotta Sill, below the Window Assembly. The top surface of the Terra Cotta is covered with grime and bird droppings. Mortar joints seem solid and intact.

View of Terra Cotta Sill – East End of Center Window

Recommendation: that the grime and bird droppings are removed; and the terra cotta cleaned.

During this procedure, the perimeter sealants shall be closely examined for deterioration, and repairs be made at that time.

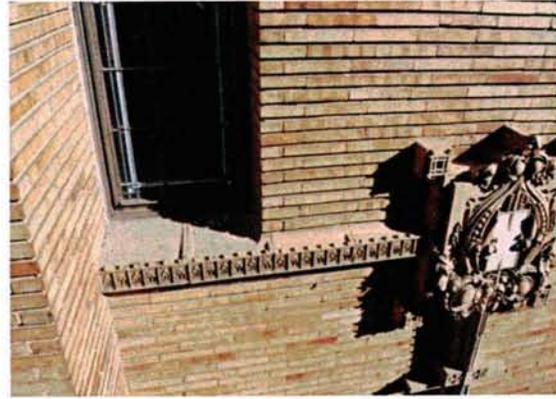
View of Terra Cotta Sill – East of East Masonry Pier

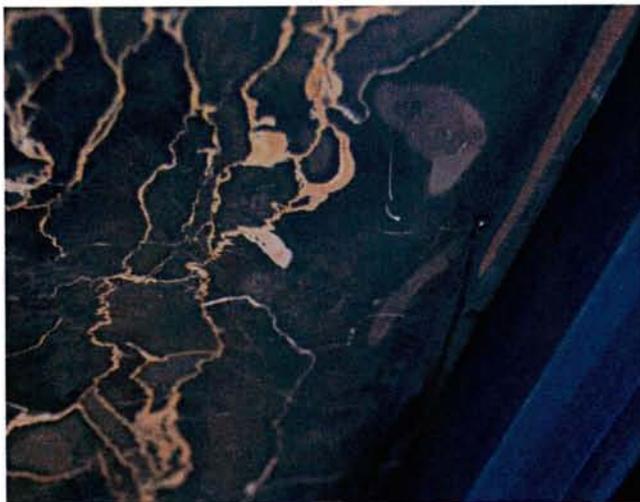
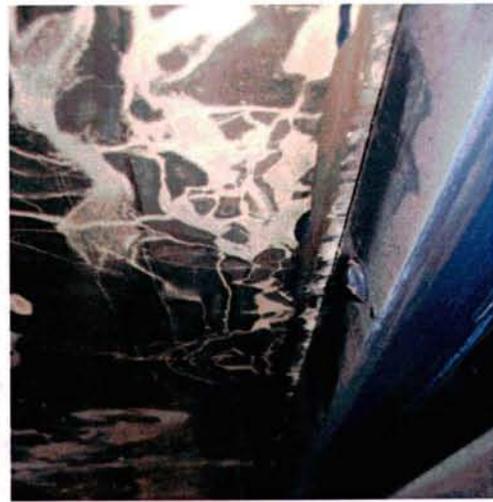
Deformation of the Steel Transom has exposed the exterior (away from the Courtroom) edge of the marble at various locations. The photos below indicate the movement of the Transom in lesser amounts.

Views of the Marble Soffit where it meets the (blue) metal trim at the top of the Lower Windows.

An earlier location of the face of the window trim is thought to be the 'brown' paint line, on the surface of the marble in both photos, (above), caused by an earlier painting of the windows. The current gap is approximately ½ to ¾ inch in the photos.

Clip Angle Suggestion: a Clip Angle, such as the one shown on the diagram on the previous page, could be screw attached to the trim channel at the window head, (or replace the trim channel), to cover the gaps at windows having that condition. Paint to match window color.

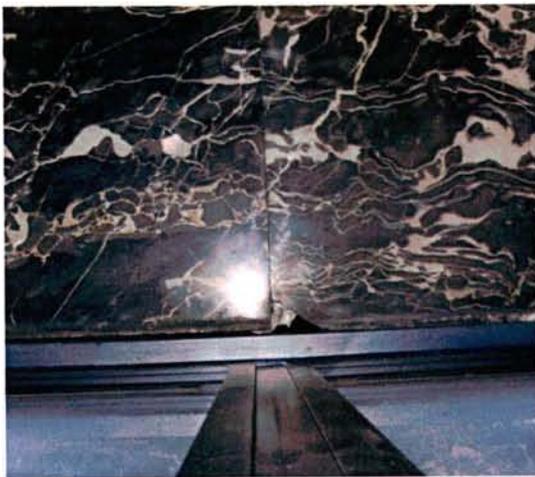
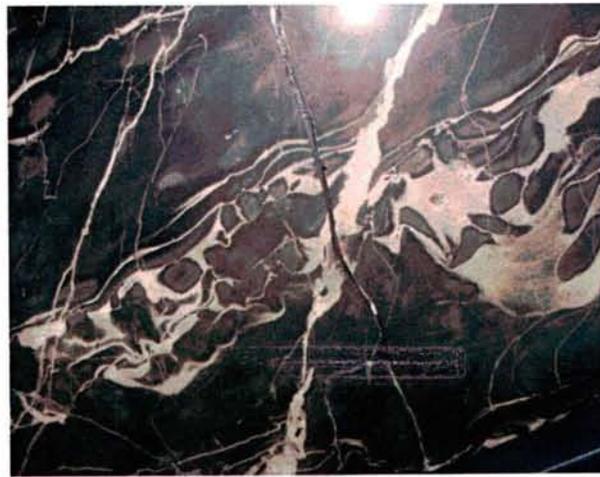
Joints in the Marble Banding & Soffits: were placed at approximately 4 foot intervals during construction of the Courthouse, except for the marble at the center of the window assembly, which is approximately 6 feet wide; (it is this 6 foot portion of marble soffit that is missing).

The marble banding and soffits have also developed random (unplanned) cracks in various places, over the life of the building, as well. This Courtroom has developed four (4) cracks in the marble banding and one (1) crack in the marble soffit.

View of a construction joint in the Marble Soffit View of a random crack in the Marble Soffit

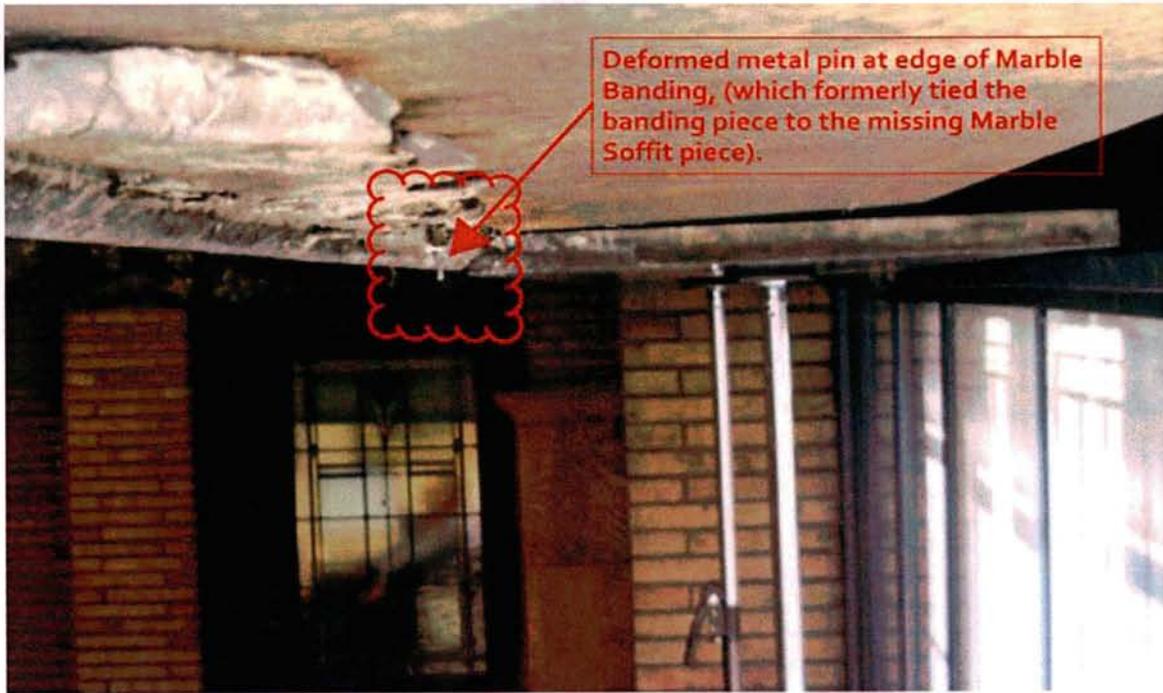
These supports failed at the missing piece of marble soffit, allowing it to fall from its place.

Deformed metal pin at edge of Marble Banding, (which formerly tied the banding piece to the missing Marble Soffit piece).

View of Underside of Transom, looking East, at area where Marble Soffit is missing.

Recommendation: provide a matching replacement for the marble soffit piece that is missing. Design a means to secure it in place that is seamless with adjacent work.

Install a continuous clip angle, (as noted at Clip Angle Suggestion, above), to provide additional support for the window edge of the marble soffit pieces

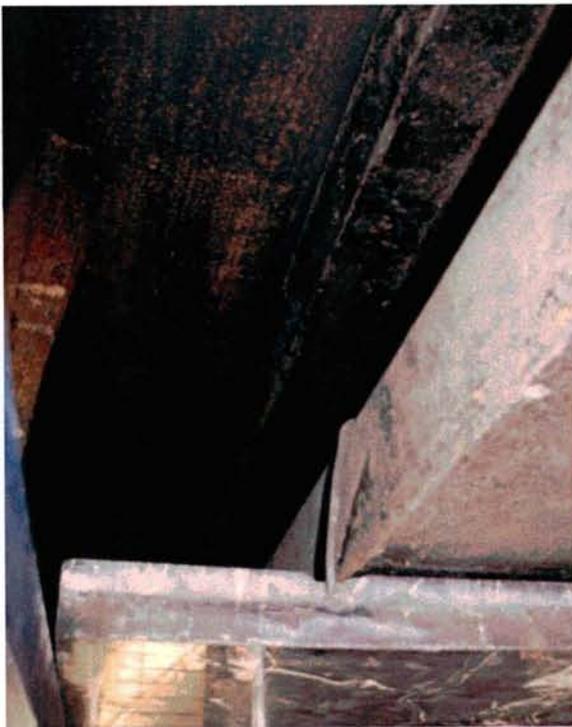
View of Underside of Transom, looking at Marble Soffit west of missing Soffit piece ; showing wire tie from connection to Marble Soffit vertically to where it clips over the steel support channel, above.

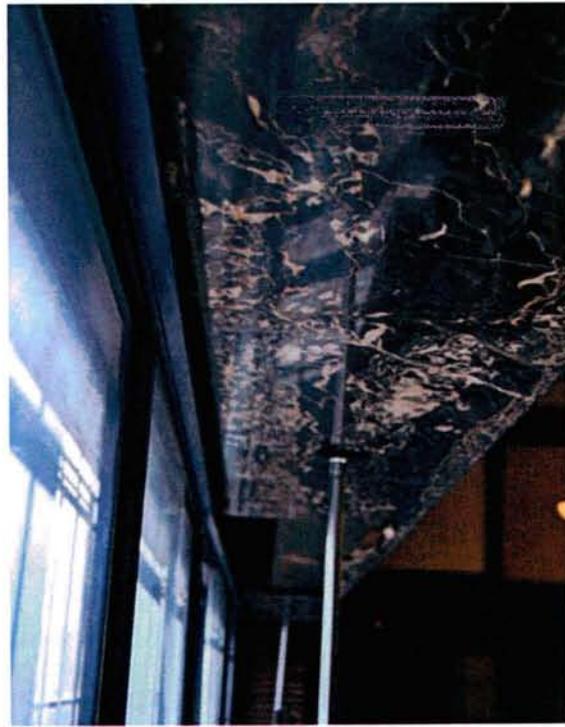
View of Underside of Transom, looking West, toward missing Soffit piece.
