WORDING FOR AGENDA ITEM: Courthouse- South East Windows Needing Emergency Repair

RE: Woodbury County Courthouse Courtroom Windows, Emergency Action

WINDOW STUDY

SOUTHEAST COURTROOM 203
WOODBURY COUNTY COURTHOUSE / SIOUX CITY, IOWA

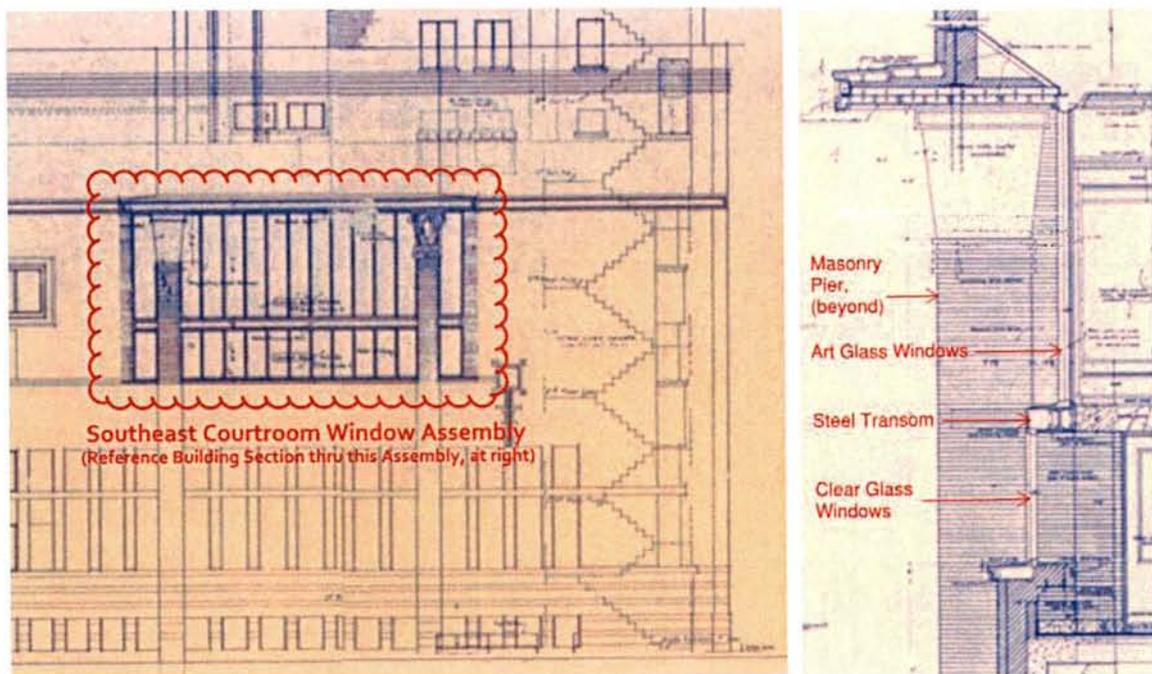
Southeast Courtroom Window Assembly

In general, the exterior/interior of the southeast Courthouse window assembly is in serviceable condition. Basic exterior maintenance is currently required: general cleaning of existing surfaces, repainting steel surfaces, and replacement of aged sealants at caulked joints.

Specific items that require more than basic maintenance, (reference expanded description under Exterior Conditions & Interior Conditions Sections, below). These items all relate to movement of the steel transom cover at the juncture between the sills of the art glass windows and the heads of the clear

glass windows, at the window assembly; (reference the Steel Transom Evaluation Notes, within the Exterior Conditions below).

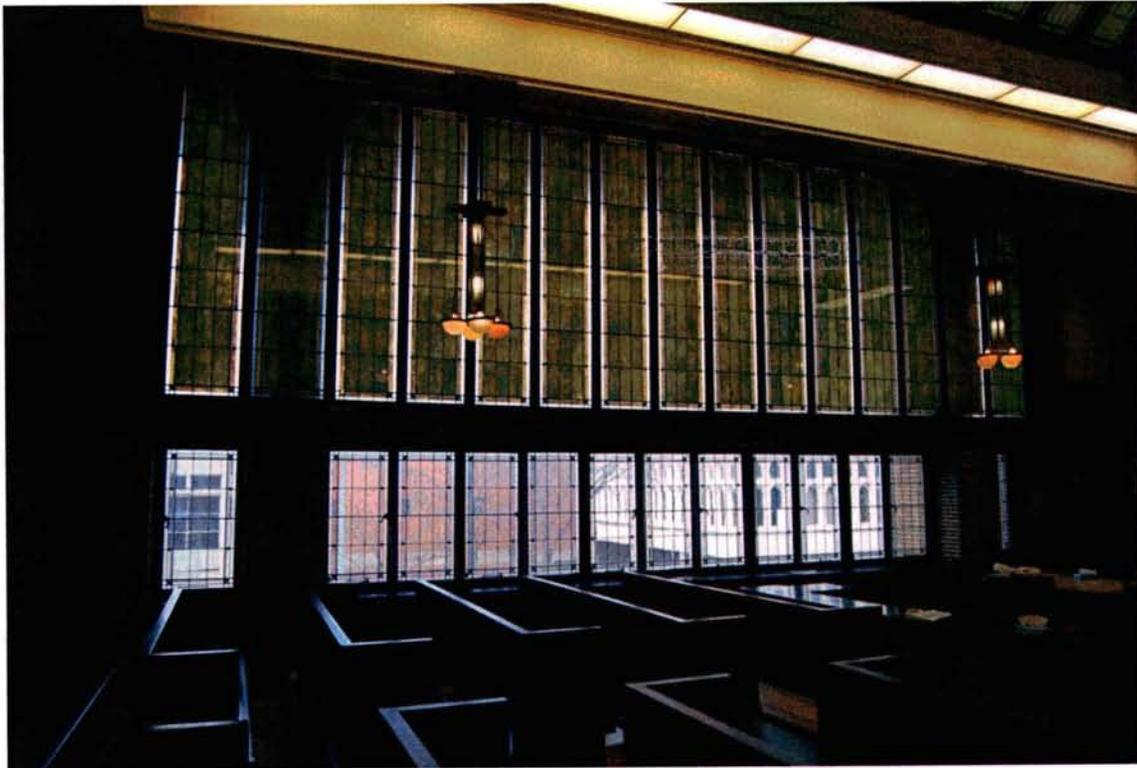
Interior View of Courtroom Window Assembly, (northeast Courtroom pictured), showing fifteen (15) Art Glass Windows above the Transom above (13) Clear Glass Windows, (separated by masonry piers into a 1 + 11 + 1 arrangement)

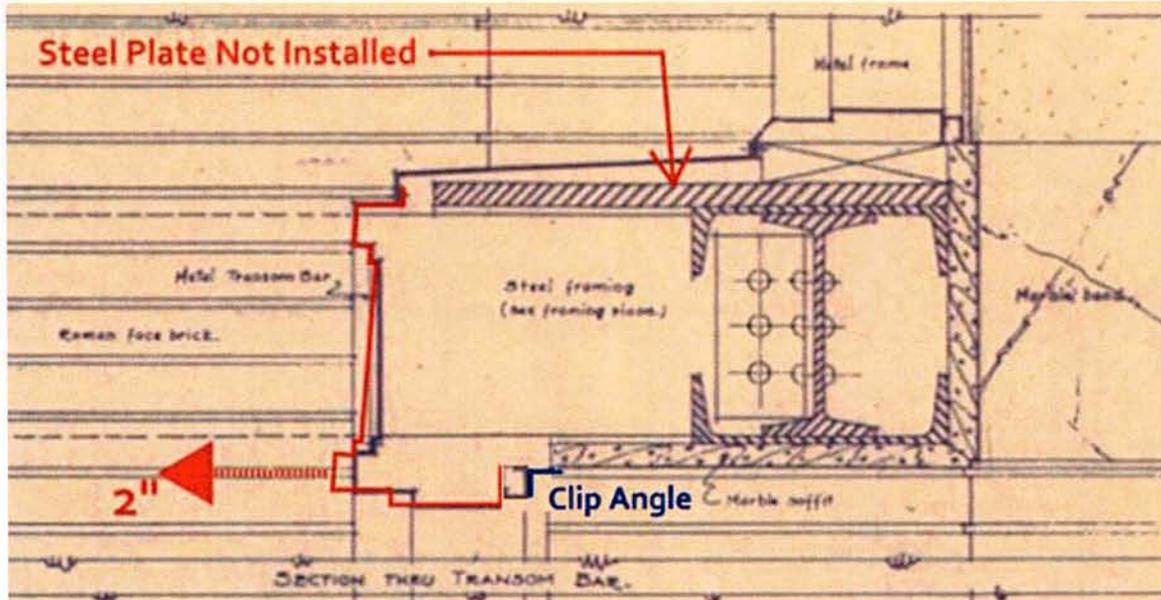
The cross-section of the Transom, repeated from the 'Steel Transom – Bowed Shape' portion of the Study, is shown below.

Note: the terminology for the marble lining the structural steel is 'Marble Banding' (for the vertical marble) and 'Marble Soffit' (for the horizontal marble).

Deformation of the Steel Transom has exposed the exterior (away from the Courtroom) edge of the marble at various locations. The photos below indicate the movement of the Transom in lesser amounts.
